UNDERWATER BRIDGE INSPECTION REPORT

STRUCTURE NO. 69580
CSAH NO. 31
OVER THE
ST. LOUIS RIVER
DISTRICT 1 - ST. LOUIS COUNTY

PREPARED FOR THE
MINNESOTA DEPARTMENT OF TRANSPORTATION
BY
COLLINS ENGINEERS, INC.
JOB NO. 3512 (CEI 1)

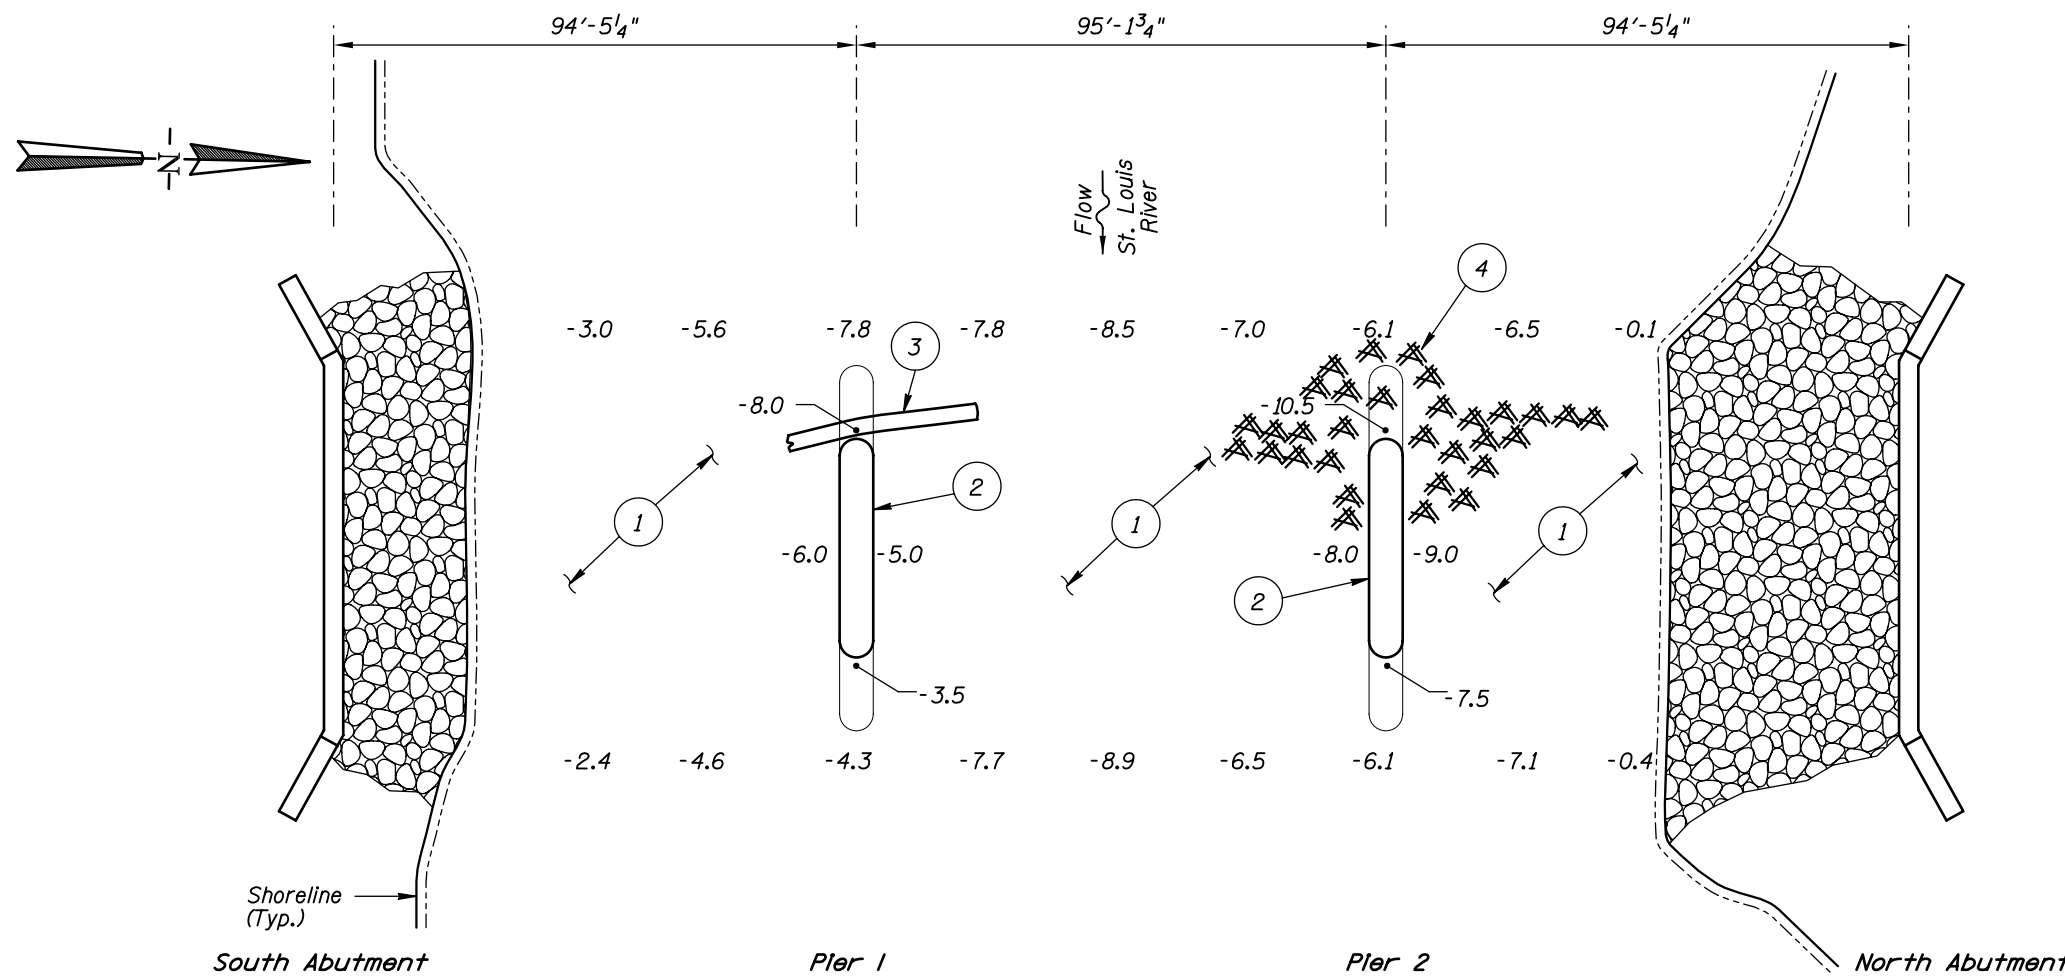
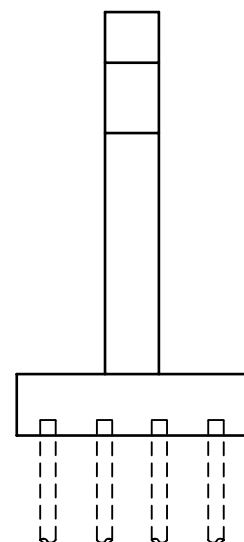
INSPECTION AND SOUNDING PLAN

- 1 The channel bottom material consisted of 1-foot-diameter and smaller riprap and cobbles with no penetration.
- 2 The concrete at both piers exhibited light scaling from 3 to 4 feet above the waterline to the channel bottom with a maximum penetration of 1/8 inch.
- 3 A 6-inch-diameter log was observed on the channel bottom across the upstream nose of Pier 1.
- 4 A heavy accumulation of 2-foot-diameter and smaller timber debris was observed at the upstream nose of Pier 2 extending from the channel bottom to 3 feet above the waterline.

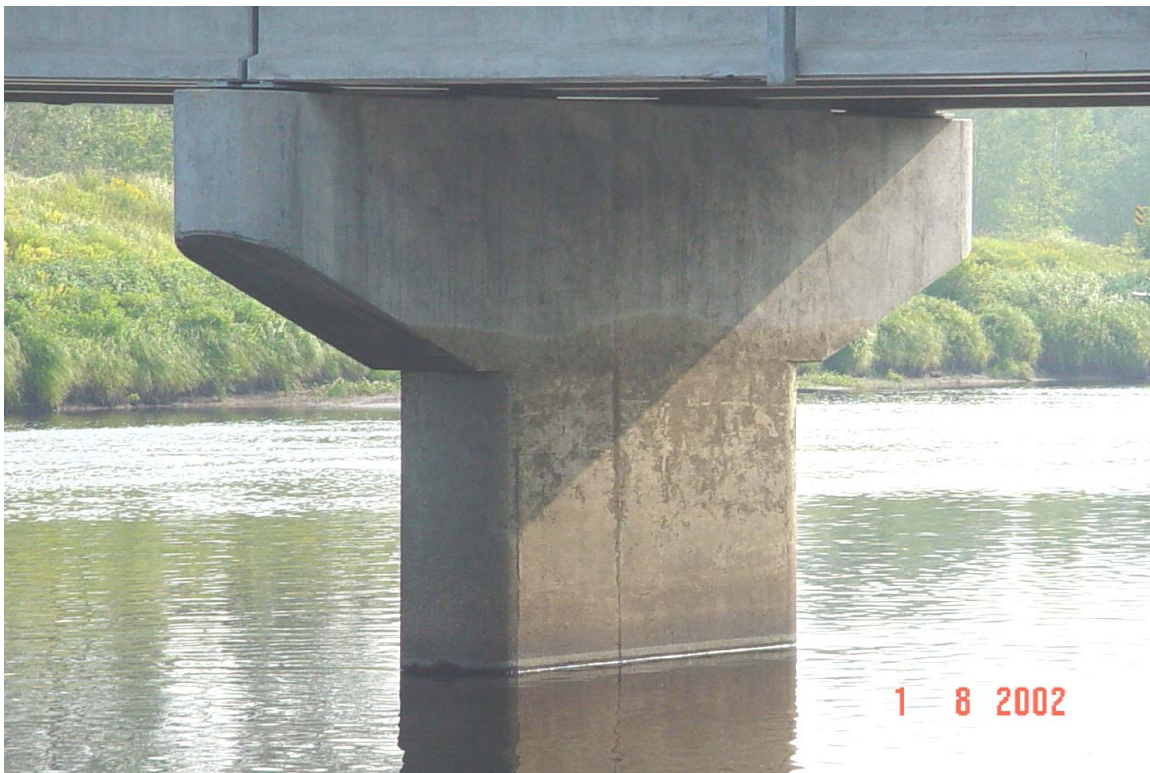
Photograph 2. View of Pier 1, Looking Northeast.

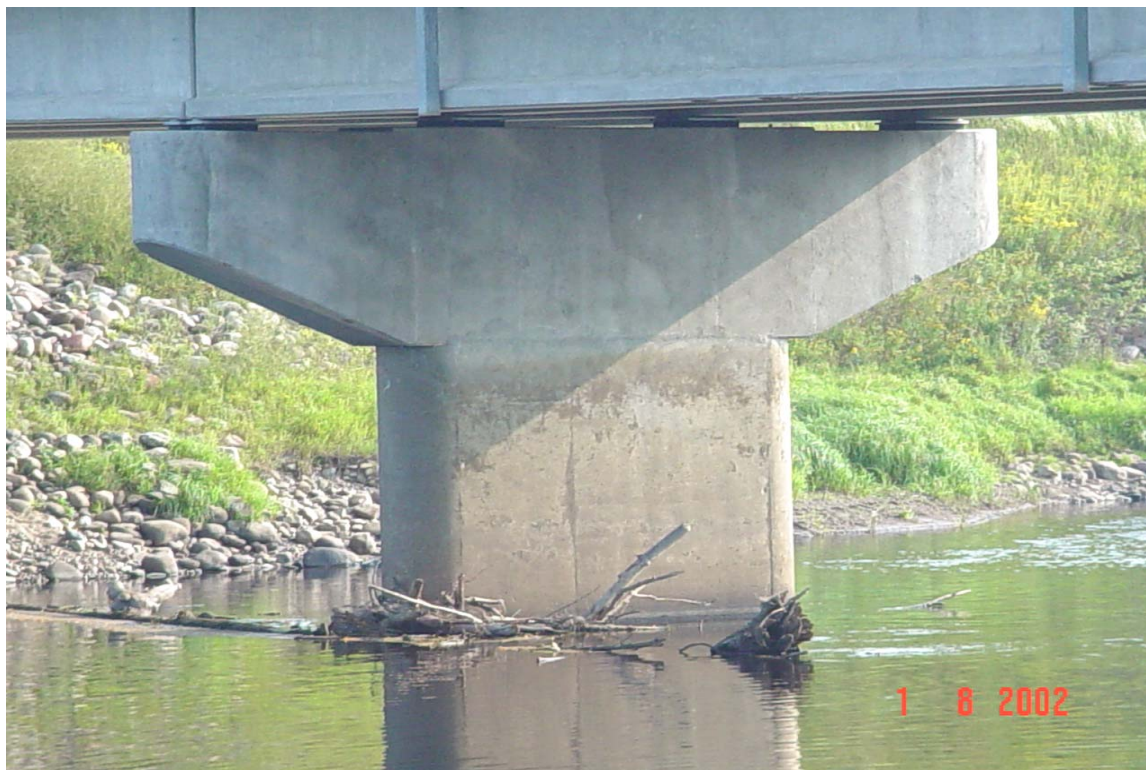
Photograph 3. View of Pier 2, Looking Northeast.

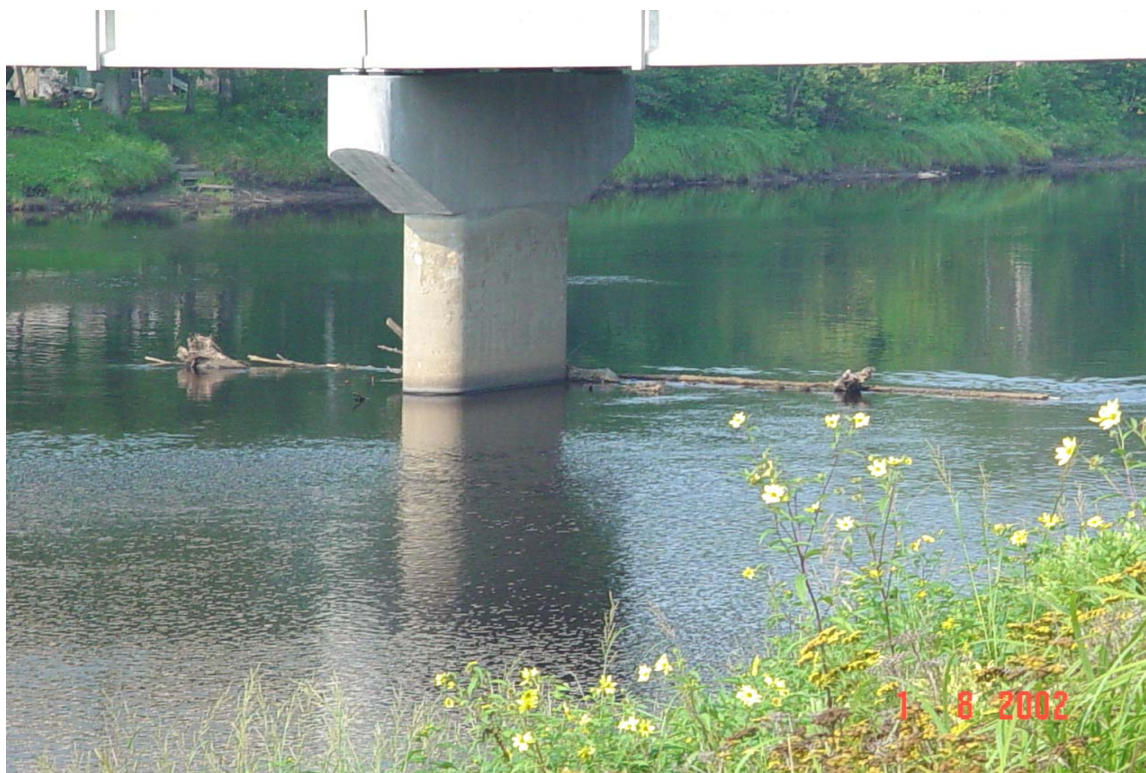
- (A) The concrete at both piers exhibited light scaling with 1/8 inch maximum penetration in a band around the pier extending from the channel bottom to 3 to 4 feet above the waterline.
- (B) A heavy accumulation of timber drift consisting of 2-foot-diameter and smaller logs was observed at the upstream nose of Pier 2 extending from the channel bottom to 3 feet above the waterline.

Photograph 4. View of Timber Debris at the Upstream Nose of Pier 2, Looking Southwest.

- (A) Remove timber debris from around Pier 2 as soon as possible to alleviate flow restrictions, scour influence, and continued accumulation of timber debris at the pier.
- (B) Reinspect the submerged substructure units at the normal maximum recommended (NBIS) interval of five (5) years.
